Article Title: Missouri Riverboat Wreckage Downstream from Yankton, South Dakota

Full Citation: Paul M Putz, "Missouri Riverboat Wreckage Downstream from Yankton, South Dakota," *Nebraska History* 64 (1983): 521-541

Missouri Riverboat Wreckage Downstream from Yankton, South Dakota

By Paul M. Putz

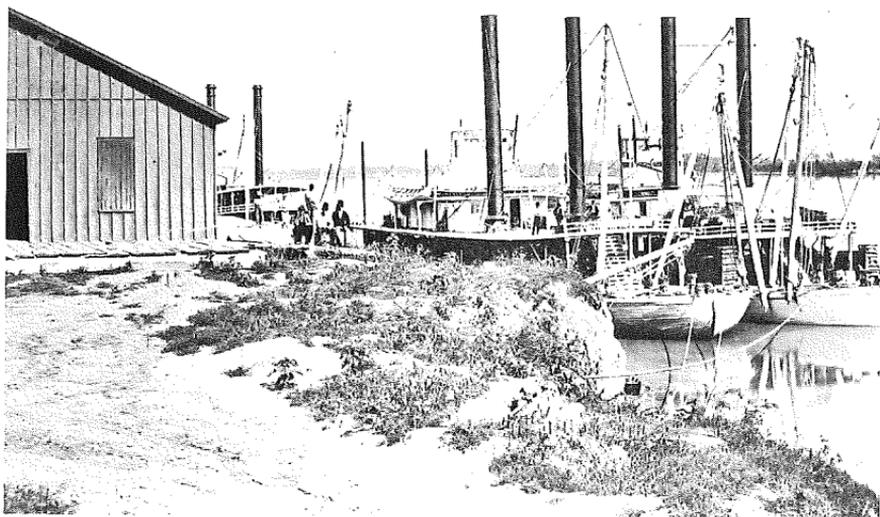
The Western at the Yankton levee, 1870s, near where it sank, with the E. H. Durfee alongside. Coulson's warehouse (left) was later used as a barn and may still be standing on a farm outside Yankton. . . . (Below) the Western submerged.

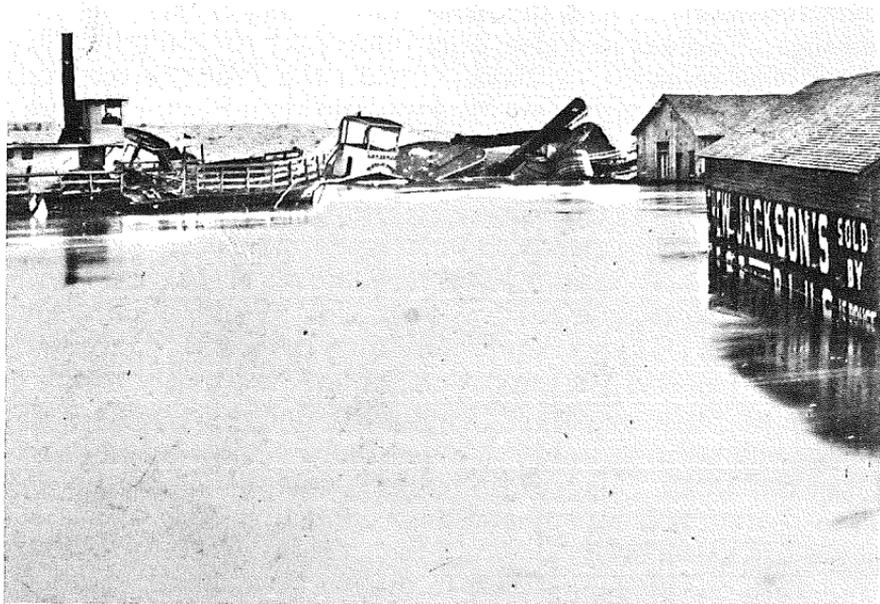
was cut down by the ice and crushed against the bank and sunk during the great gorge of ice at Yankton. After the boat sank a large field of ice ran against her with such force as to flatten her port boilers.²³

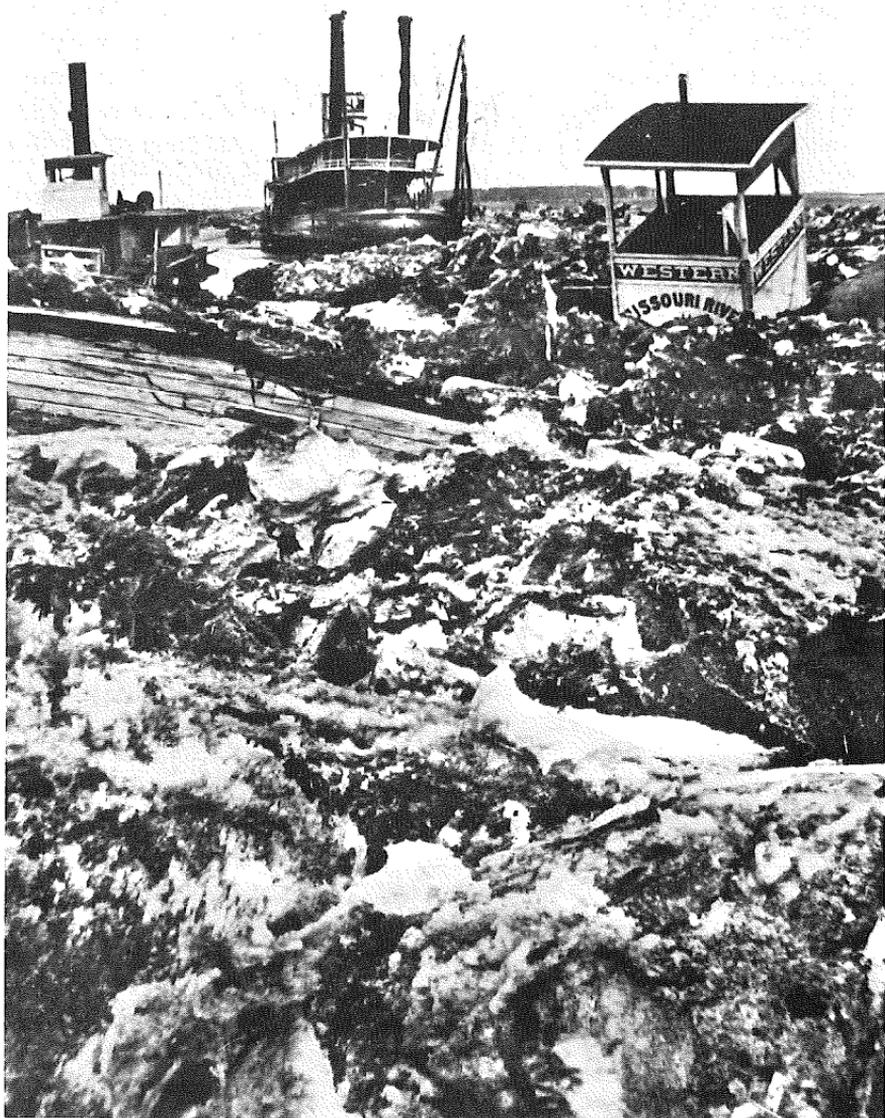
The forward section of the Western's hull, with the ice center at left, April, 1881. Much of the superstructure has been cut away except the pilothouse, leaving the twisted hull for salvage. Somewhere to the right of and over 10 feet below the pilothouse is the inverted stern.

The fact that the *Western* was twisted in two by the ice demonstrates the enormous force of the flood which sank her. The stern, which sank first, was somehow overturned by that force, leaving the bow to be smashed against the bank. When salvage operations were undertaken, it would have been necessary to cut at the stern section from above the inverted hull. Marks left by such operations would be similar to those found at the site. Over the century the wreckage lay on the river bottom; however, it may have been the source of lumber or firewood for others who may have encountered it there.

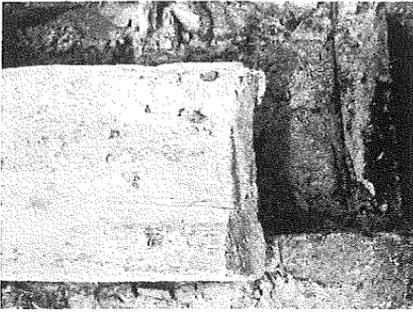
Salvage marks on hull planking. Rib to which the plank was spiked is visible below. . . . (Right) Broken ribbing over what appears to be the vessel's central keelson.

Finally, there is the presence of salvage marks of the planking of the hull. If it is assumed that salvage operations were carried out on the wrecked boat immediately after its sinking, then these would be most relevant to confirming the identity of the discovery. It is evident that these marks were made from above the hull as it now lies, which is consistent with the experience of the *Western* after the ice and water that engulfed her had receded and attempts at recovering parts of her were made. At that time it was reported:

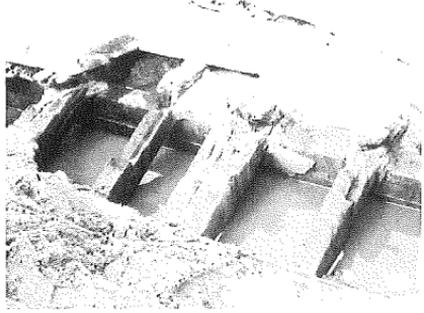
The cause of the slight rise which brings the wreckage out of the sand at this point seems to be a large timber extending along the assumed center of the hull. Where this member is prominent, the attached ribs are broken as if through upward movement or resistance to further settlement. The two 6 x 6 timbers of which this feature is made are secured one above the other and at intervals along its length tapered 2 x 2s are fastened perpendicular to it. These continue down into the sand for an undetermined distance. The ribs at this juncture are notched on the planking side at a depth of about an inch and for a foot in width. No reason for these notches was determined.

central keelson often served as the foundation for a bulkhead running the length of the hull. The large 6 x 12 member in the center of the Yankton wreck is possibly such a feature.

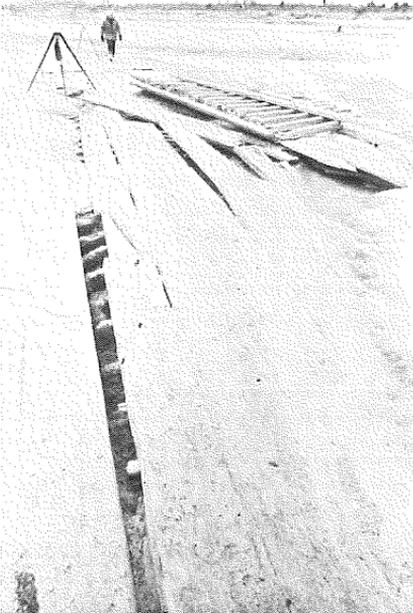
wreckage appears to be built identically to its partner, both probably being parts of the same hull area. It is exposed for a length of about 50 feet dipping to the southeast and consists of eight planks rising out of the sand to form a low wooden mound. In places at the eastern end of the section the planks terminate, exposing ribs beneath. Along their length the planks are linked together in a manner referred to as scarf jointing. This method is not consistently applied, however, for occasionally the planks are simply butted together and nailed into a rib below.

Wreckage is visible above the sandbar. In foreground is the inverted hull, the assumed centerline of which extends along the separation between the planks. A "scarf joint" appears in the central plank. Behind is the upright hull section with chines and footline.
