Article Title: How Did They Do That?

Article Summary: This article contains an explanation of the straw bale structural system of the Lone Oak Building, built in 1944 six miles west of Lincoln, Nebraska.

How Did They Do That?

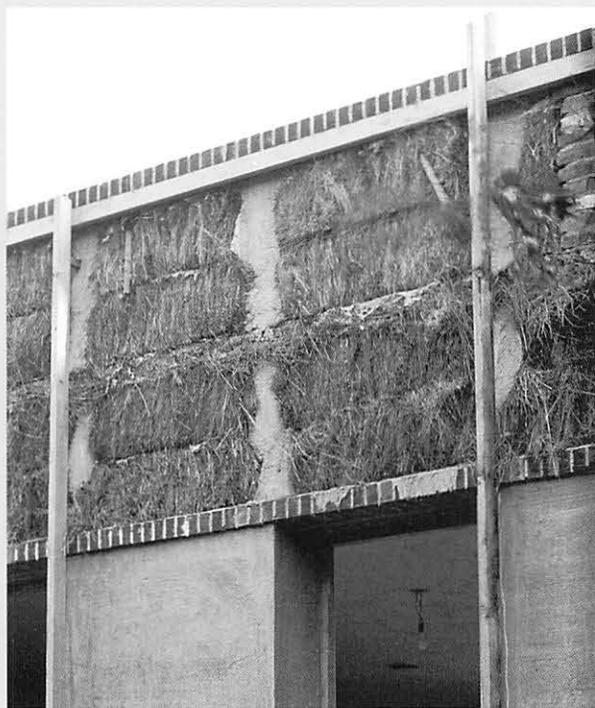
Figure 1. NSHS
RG2183-1945-0730-3

A construction view (Fig. 1) includes what appear to be temporary light vertical frame members along the walls. The detail here shows that the members hold stakes set in the concrete mortar between the bales. It appears the verticals are keeping the wall plumb while the mortar and

surface stucco set. They also carry a horizontal member supporting the lip of a continuous brick rowlock course while its mortar sets. The vertical members suggest that the bales are load bearing. Had they been a “veneer” on some other structure, such as a stud wall, the verticals would not have been needed; the bales could have been anchored to the studs. There are similar members on the face of interior wall. They appear to be held by wires passing through the bale and tied to stakes.
