“Pretty Well Fixed for Defense”: Enclosed Army Posts in the Northern Plains, 1819-1872

“Pretty Well Fixed for Defense”:

ENCLOSED ARMY POSTS IN THE
NORTHERN PLAINS, 1819-1872

BY THOMAS R. BUECKER

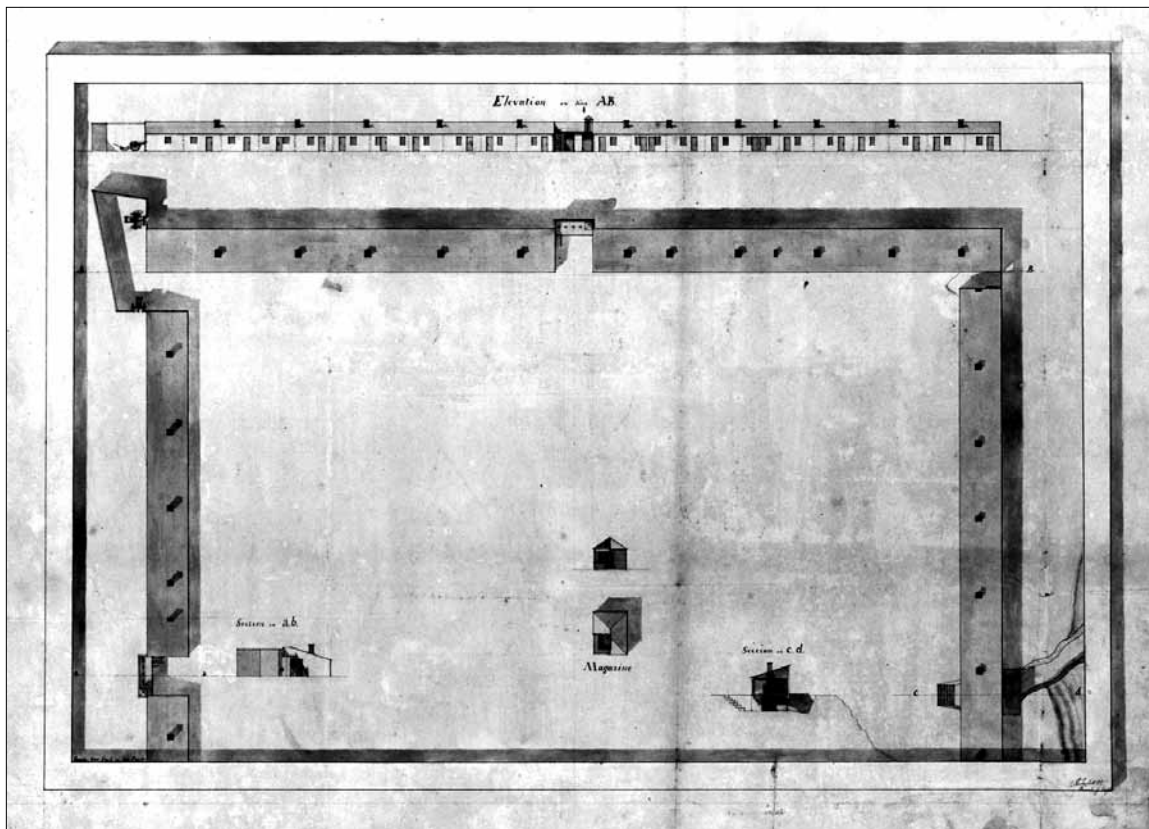
Figure 3: Plan of the north half of Fort Atkinson, showing the northwest bastion, with the Missouri River on the east (right) side, and the magazine in the center of the parade ground. Library of Congress

and replaced by Fort Atkinson in 1820 (fig. 3). At that time, Fort Atkinson was the largest army post in the United States, with each side of the fort enclosure more than two hundred yards long, and a capacity of one thousand soldiers, plus dependents. The first Fort Sully, built in present-day central South Dakota in 1864, was another example of a building-enclosed fort. Fort Mitchell, Nebraska, a small one-company post also built in 1864, was building-enclosed on three sides, with a stockade-protected corral adjoining on the east (fig. 4).

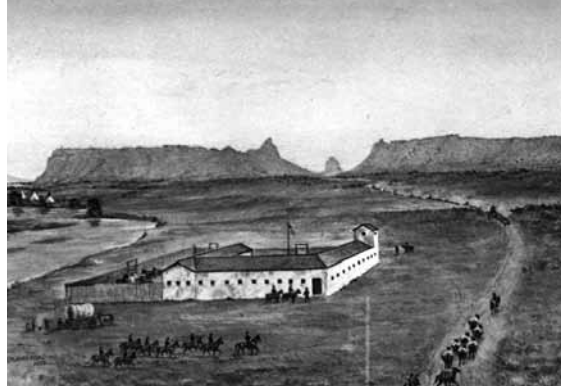
Figure 4: Fort Mitchell (1864-67) on the North Platte River with Scotts Bluff in left background, as painted by William H. Jackson.
 William Henry Jackson Collection at Scotts Bluff National Monument

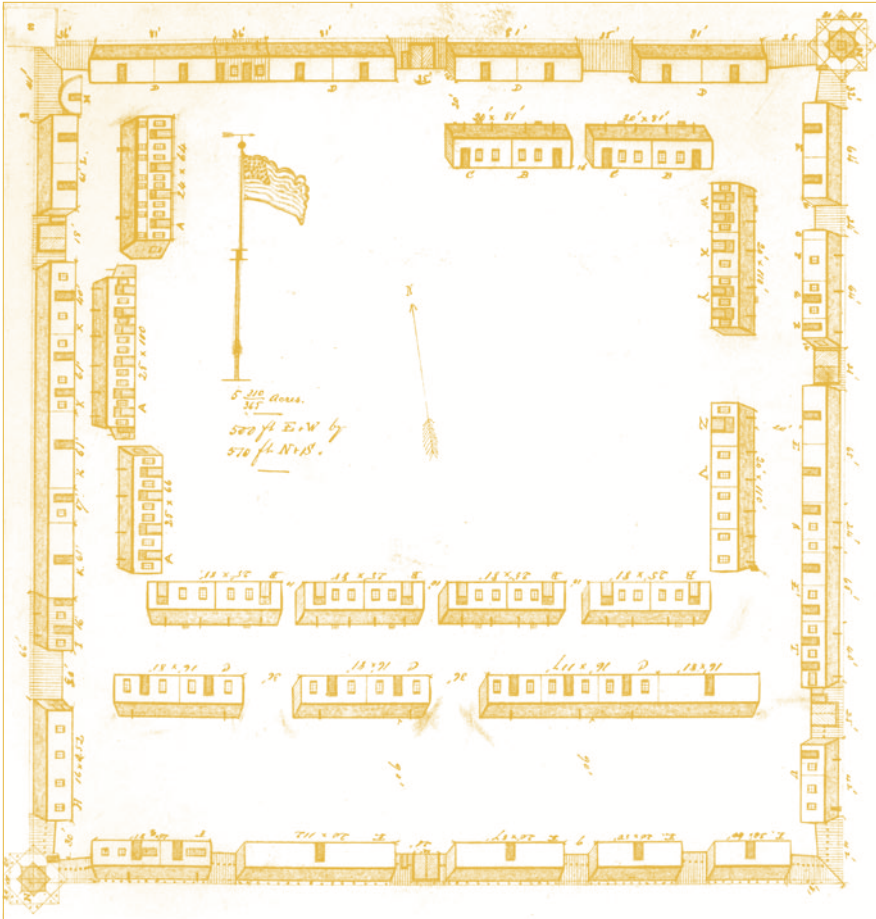
Figure 7: (Above) Plan of the first Fort Rice, an example of a combination-enclosed fort. Minnesota Historical Society

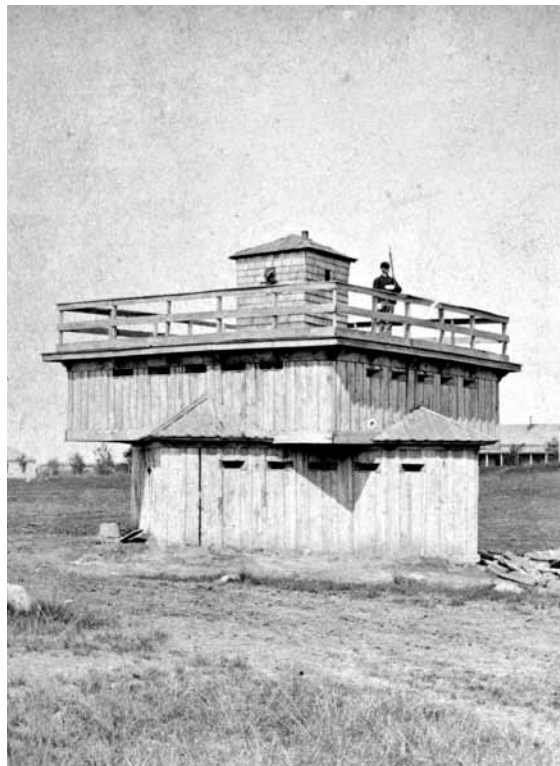
Figure 8: (Right) One of the three blockhouses built to protect Fort McKeen, the infantry post of Fort Abraham Lincoln. State Historical Society of North Dakota (A5822)

A blockhouse was a small fortified building used as a flanking device in enclosed forts. Blockhouse design and purpose changed little from the earliest forts built on the American frontier. The first military blockhouse built on the northern plains was at the original Fort Kearny, built in southeastern Nebraska in 1846. At some posts, blockhouses were built as strongholds without a defensive wall. After touring western posts in 1866, Gen. William T. Sherman, commanding general of the United States Army, stated that army posts should have "two or three blockhouses" so that a few men in each could cover the perimeter with protective fire.⁴ As a result, freestanding blockhouses appeared at several new forts, including

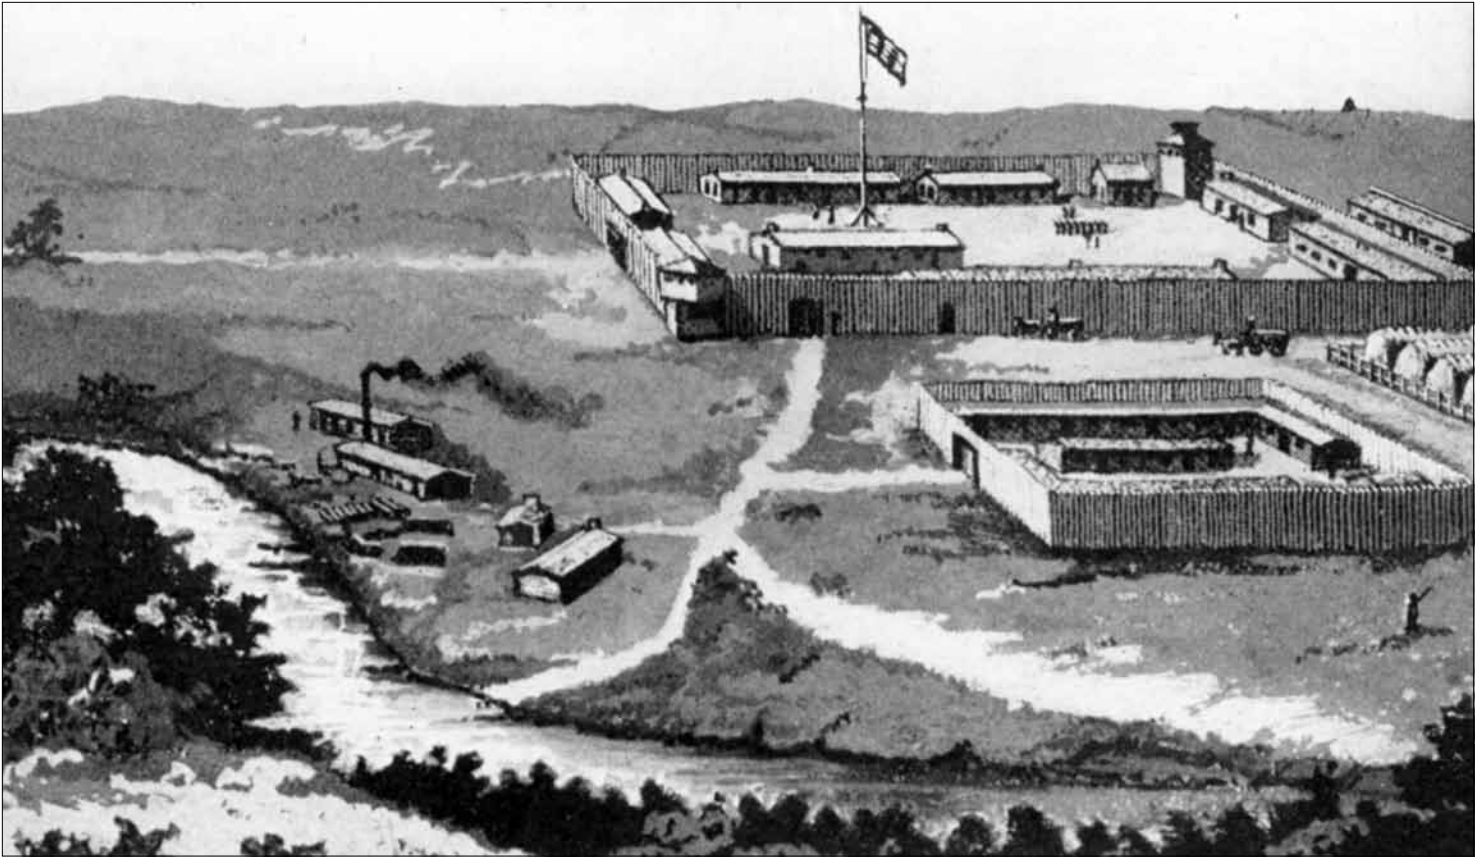
Figure 11: Enclosed by a log palisade, Fort Reno was the first fort on the Bozeman Trail. The separate palisaded quartermaster corral was 120 feet square.
NSHS RG2448-2

and fifth log.¹ Another enclosed fort was Fort Reno (1865-68, fig. 11), also on the Bozeman Trail, where its palisade walls were a separate construction feature that surrounded the buildings. A separate wall is also apparent in the original plan of Fort Ellis, built in 1867 in Montana Territory.²

Stockade construction depended upon the skills of the builders. The first wall built around Fort Reno was carelessly constructed of cottonwood lumber. It had to be dismantled soon after completion and the logs cut to even lengths, realigned, and reset. Other stockade disadvantages were noted at Fort Reno. During Indian alarms, so many men watched the action from building roofs, stockade walls, and

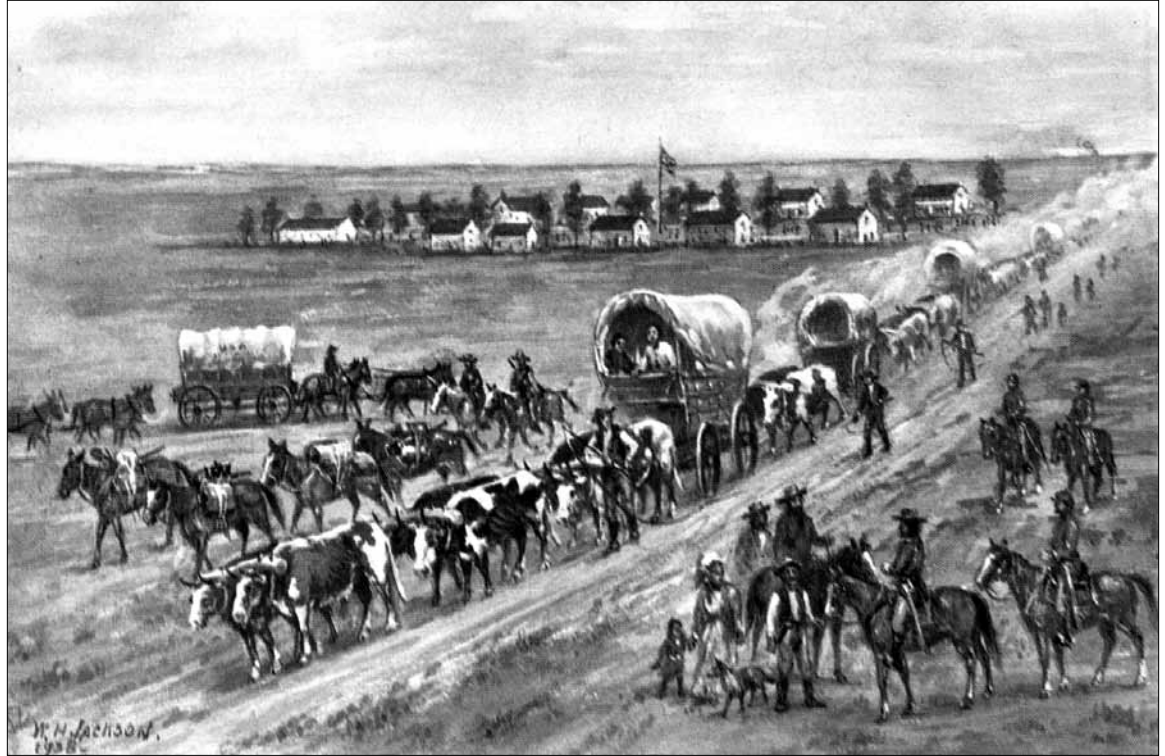
Figure 12: Always an open post, Fort Kearny disappointed many travelers on the Overland Trail who expected to see a true fortification.

Because there were no walls or fortifications at open forts, travelers passing by were frequently confused and disillusioned. This was particularly the case at Fort Kearny (fig. 12), where one early visitor commented, "I had never seen a fort before and confess I had a good idea of curiosity to see this one . . . I was greatly disappointed with its appearance." Some passersby mistook the fort for a trading post.¹⁶

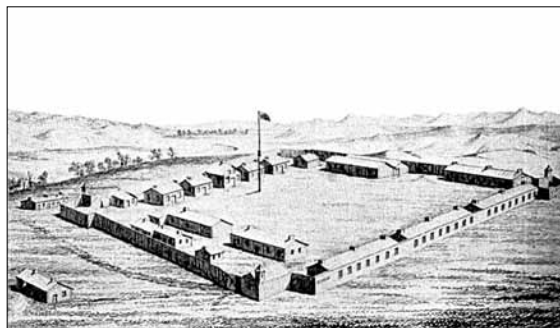
Figure 13: Originally built as a palisade-enclosed fort, Fort C. F. Smith, the third post on the Bozeman Trail, was rebuilt as a combination type. The enclosure was formed by log palisades filling gaps between adobe buildings.

the back walls of separate buildings, with log palisades filling in the gaps. An excellent example was Fort C. F. Smith (the third fort built on the Bozeman Trail, fig. 13), with log walls set between adobe buildings. Fort Rice is another example, as originally constructed in 1864 on the Missouri River in south-central Dakota. In the plan shown here (fig. 7), sections of palisade fill in between the buildings. The first Fort Totten, also in North Dakota, and Fort Cottonwood, later to become Fort McPherson, Nebraska, were both examples of combination construction.

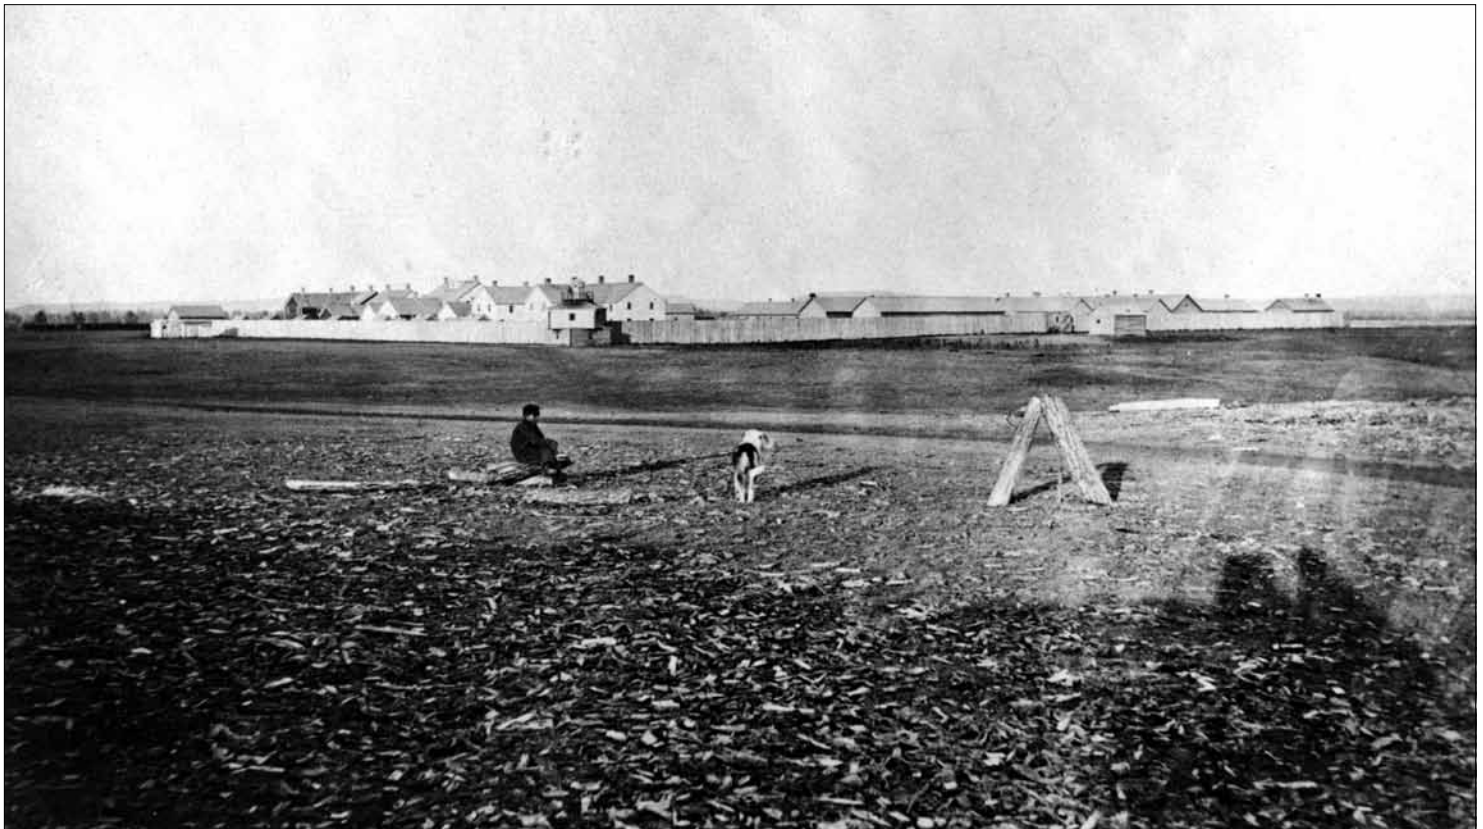
Figure 14: The new Fort Rice, rebuilt with frame buildings surrounded by a ten-foot-high plank palisade with protective blockhouses. State Historical Society of North Dakota (B0764-04)

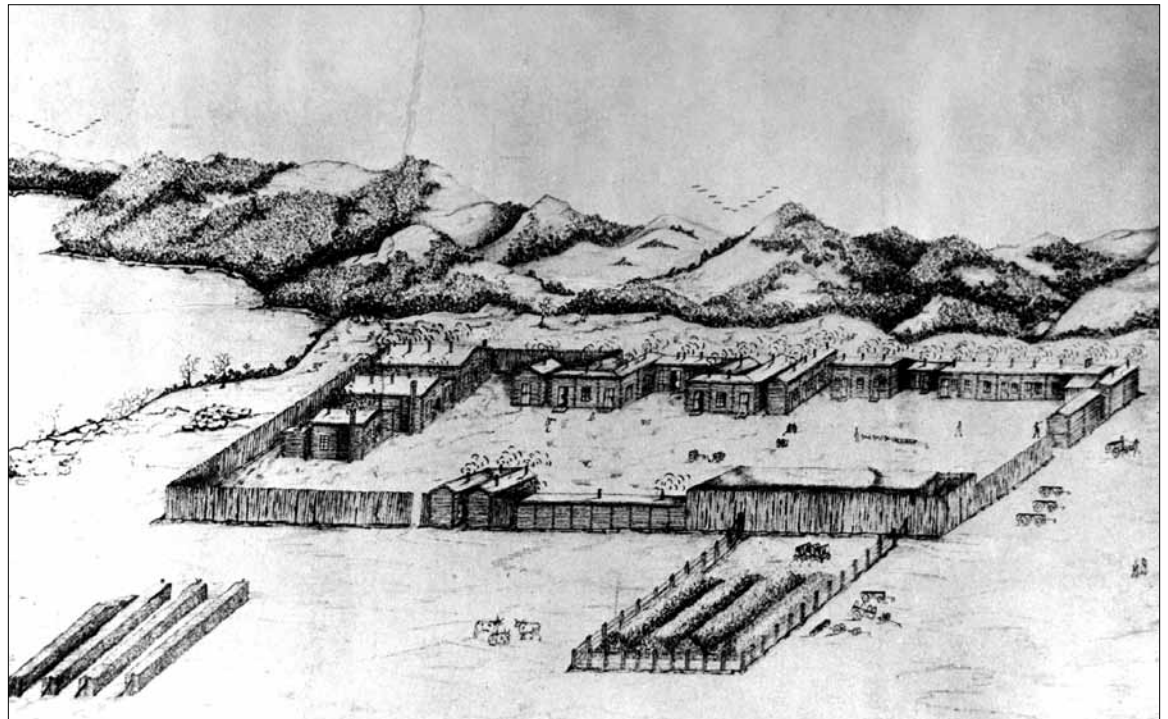
Figure 15: The first Fort Totten, North Dakota, built in 1867, was a combination-enclosed fort. Devils Lake is to the left. National Archives

On the northern plains, seven forts were originally built with palisade walls. Wall height was certainly not standard, varying from eight feet at Fort Phil Kearny, to a wall eighteen feet tall reported at Fort Totten (fig. 15).
